# **ROOF ASSESSMENT REPORT**

**TOWN HALL MAIN ROOF  
ONE AVENUE A  
TURNER FALLS, MA 01376**

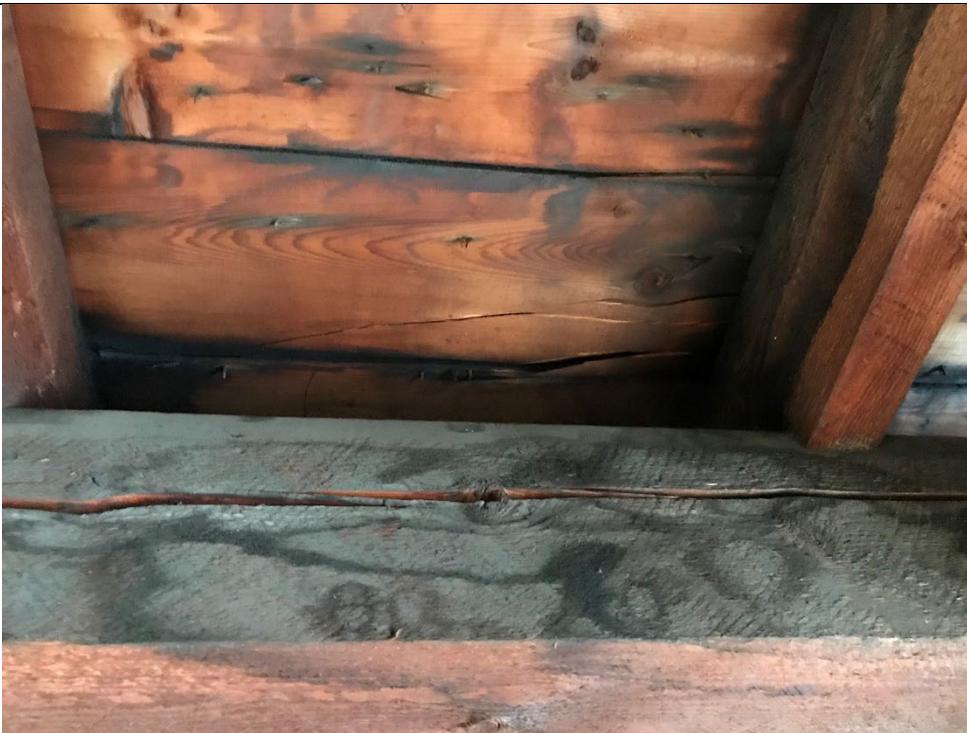
**Photo R2**  
01/06/22

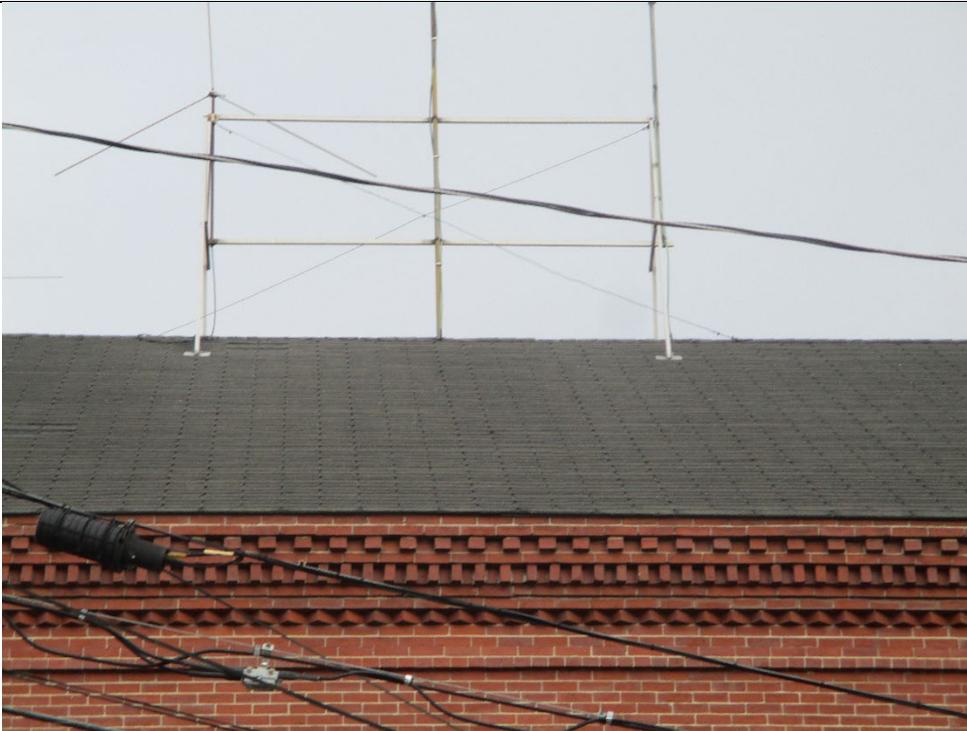
**Photo R4**  
01/06/22

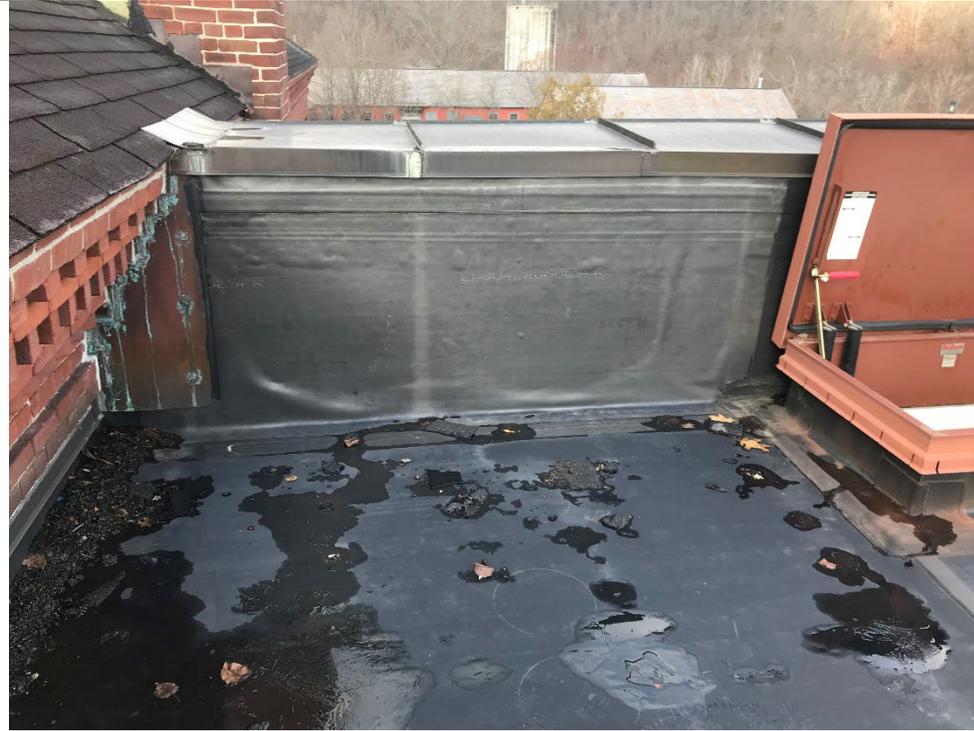
**Photo R9**  
01/06/22  
*Photo Location:*  
Rear Stairwell Roof

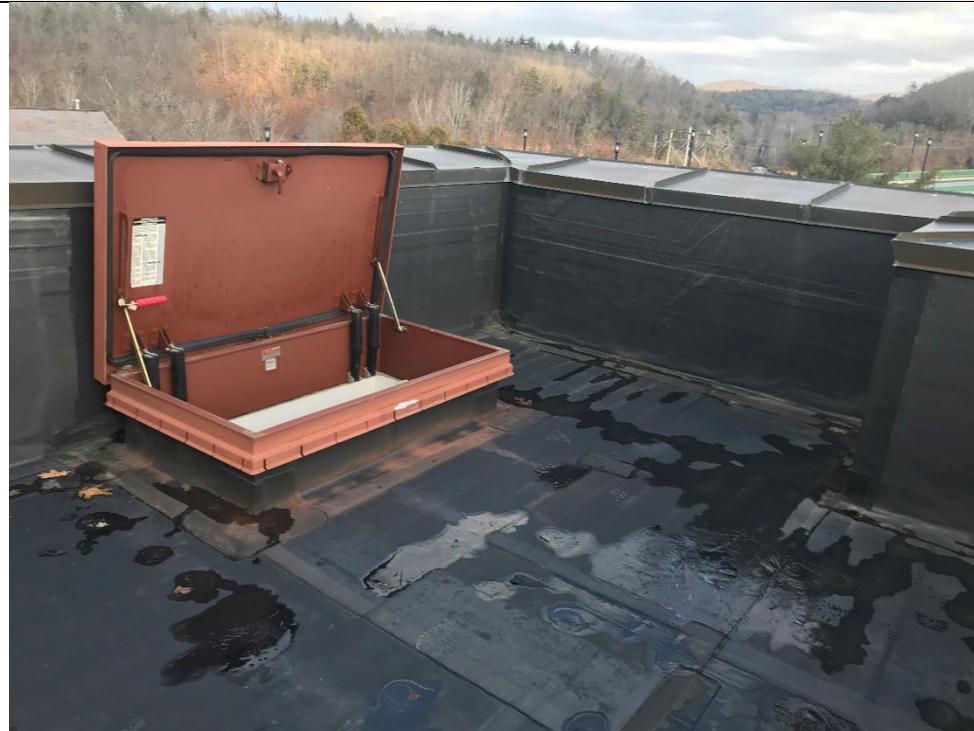
**Photo R10**  
01/06/22  
*Photo Location:*  
Rear Stairwell Roof

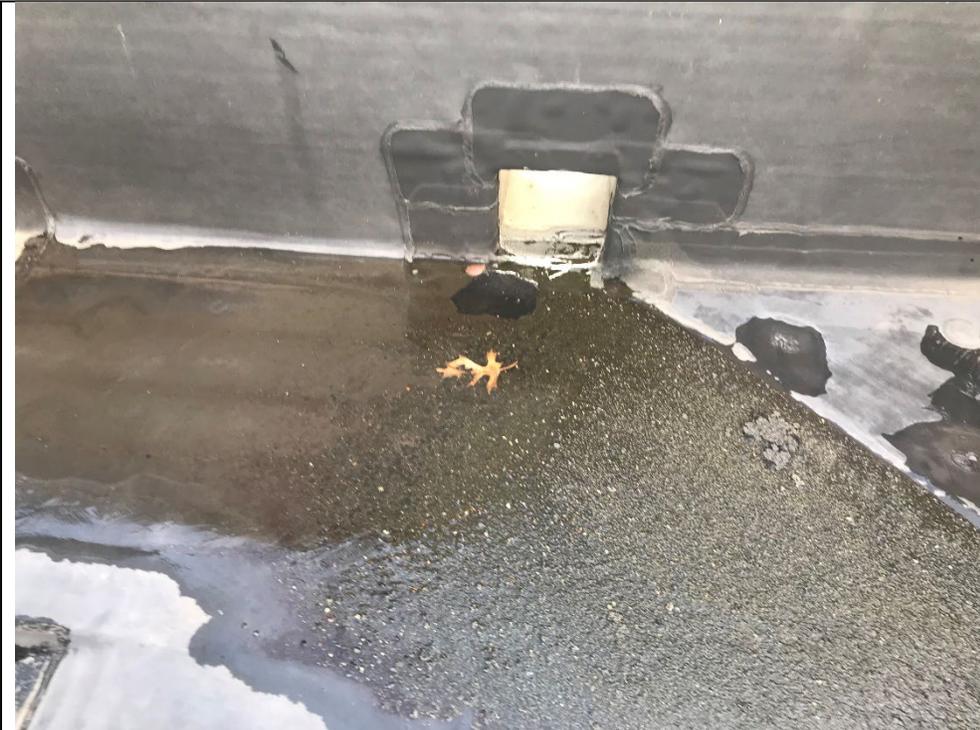
**Photo R11**  
01/06/22
